# Insight

Non-Destructive Testing and Condition Monitoring

May 2013

**Volume 55 Number 5**

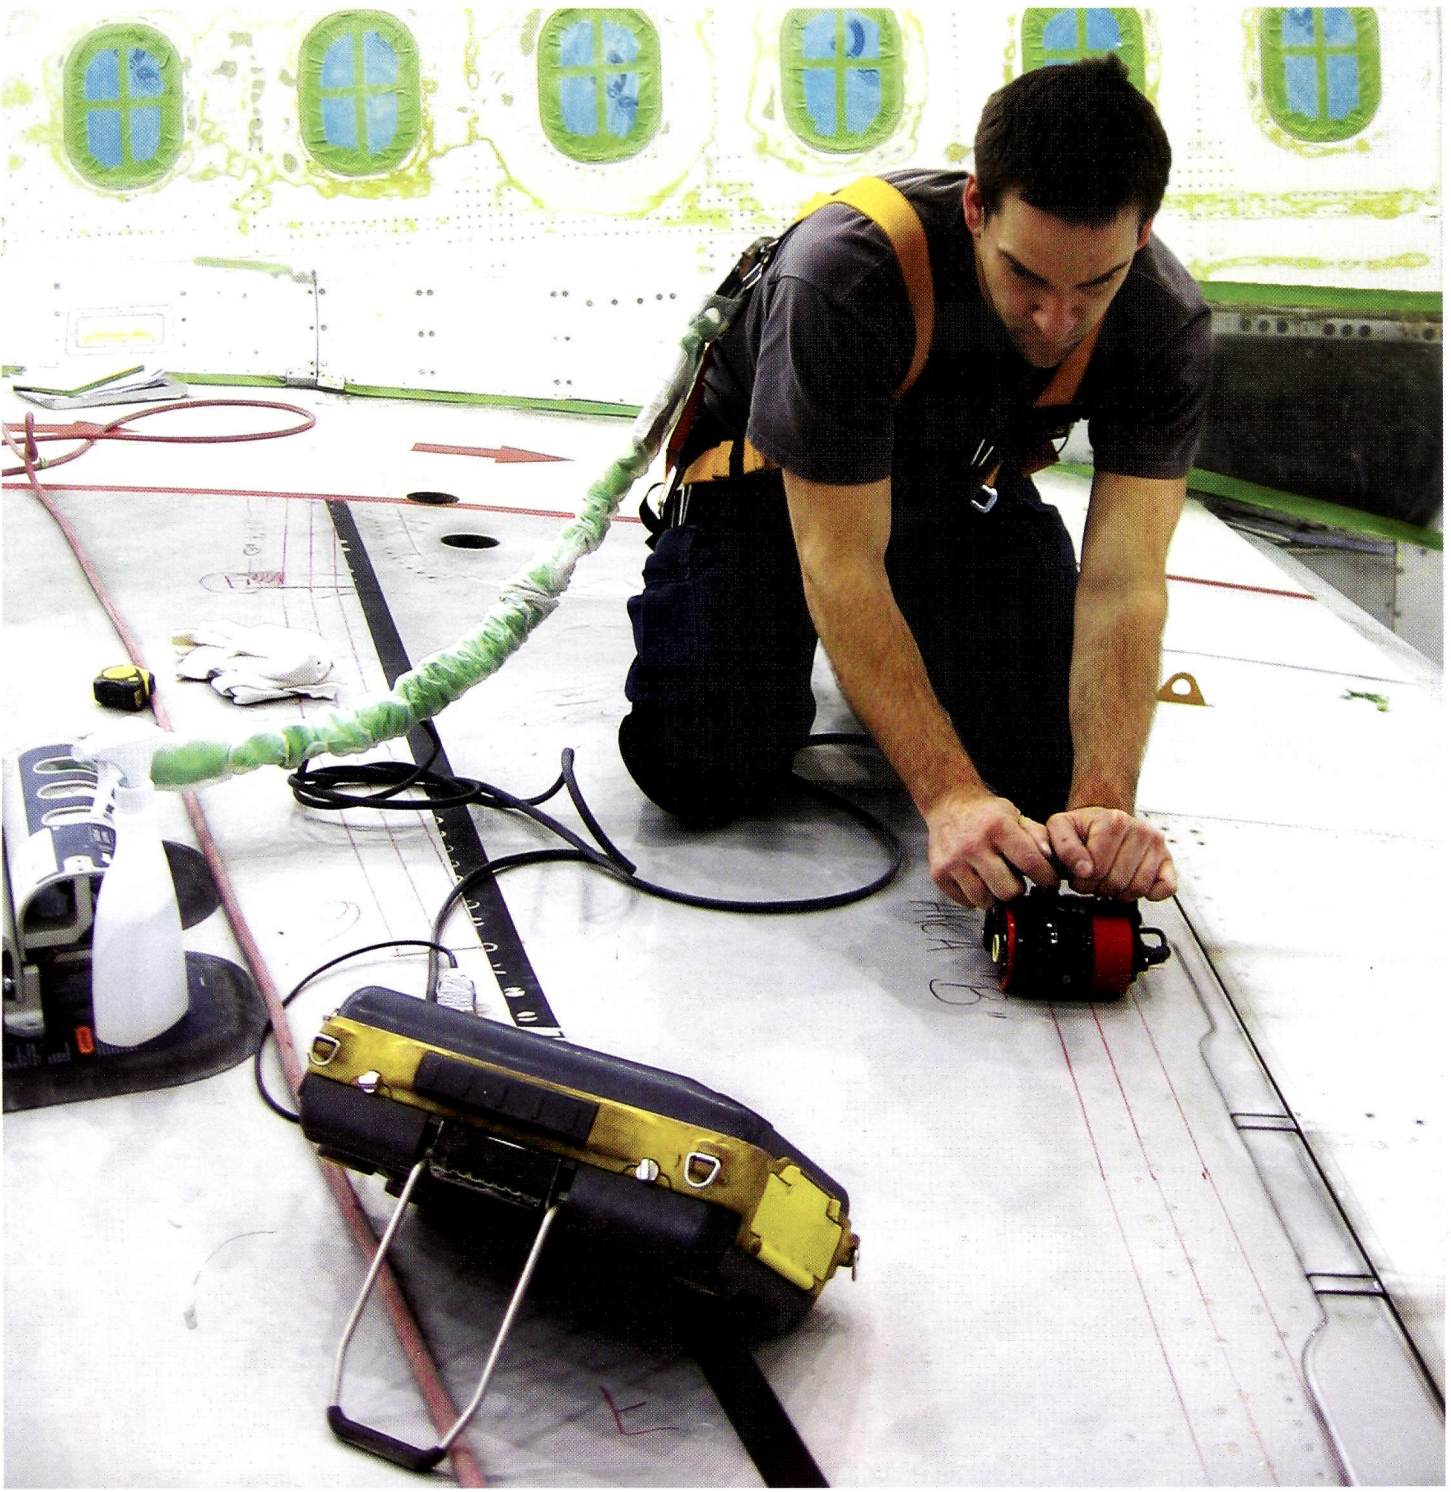
**COVER**

This month's front cover depicts an aerospace phased array inspection of the upper wing skin, between the trailing edge and the forward fastener row on the rear and false spar, using the Sonatest Veo and Radius Wheelprobe. The Radius Wheelprobe enables fast encoded scanning of large areas.

This inspection identifies areas of corrosion that occur at the edge of the wing top skin and around the rear spar fasteners, which then reduces the metal thickness from the lower surface. Following the manufacturer's procedure, the inspector identifies the inspection zone and constructs lines for scan paths. Variations in signal amplitude and thickness readings will confirm signs of corrosion or material loss.
